## Matthew Jones House

Historic Maintenance and Repair Manual

### **Final report**

Under   Project # 396574, "Matthew Jones House Maintenance & Repair Manual."

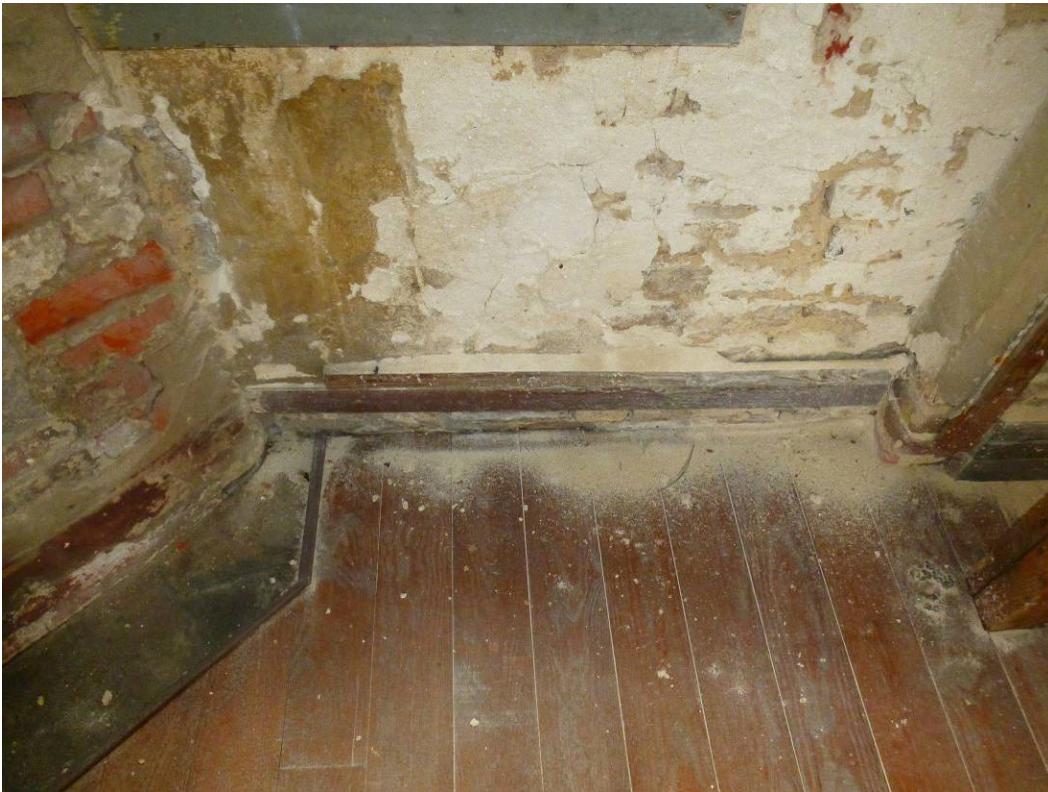
Figure 192. Failing plaster is evident with the piles of “dust” on the wood floor in the shed room (rear chamber) addition adjacent to the fireplace (ERDC-CERL, 2012).

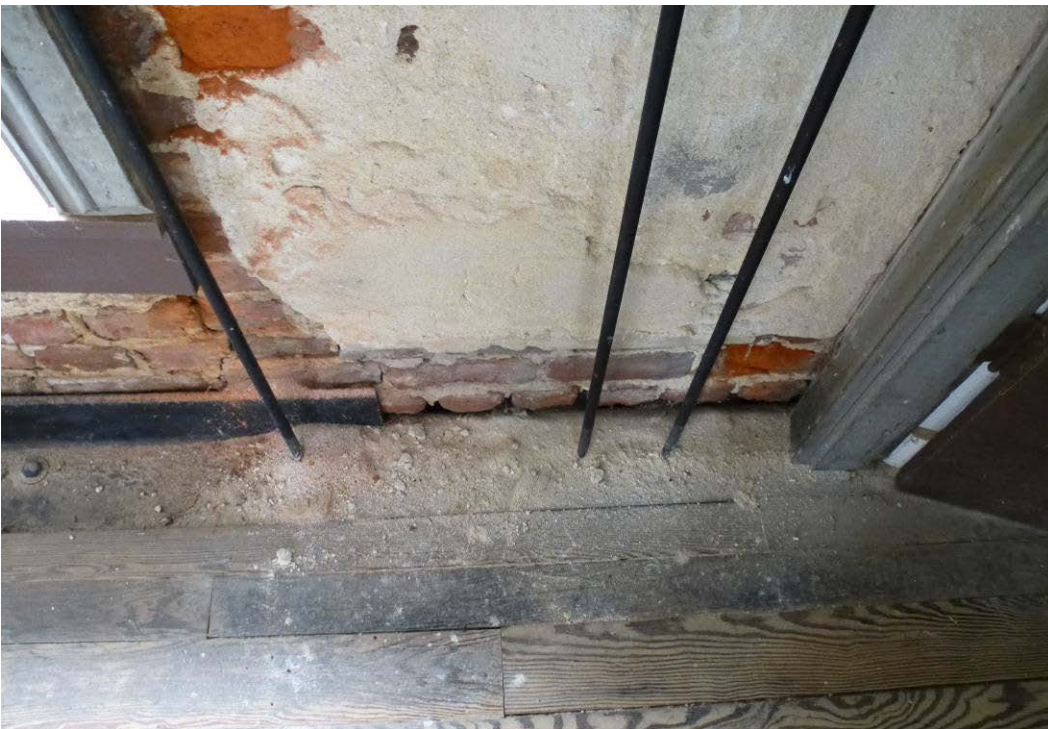
Figure 193. Plaster and brick dust pile around the steel rod enforcement in the upper stair passage on the northeast wall (ERDC-CERL, 2012).

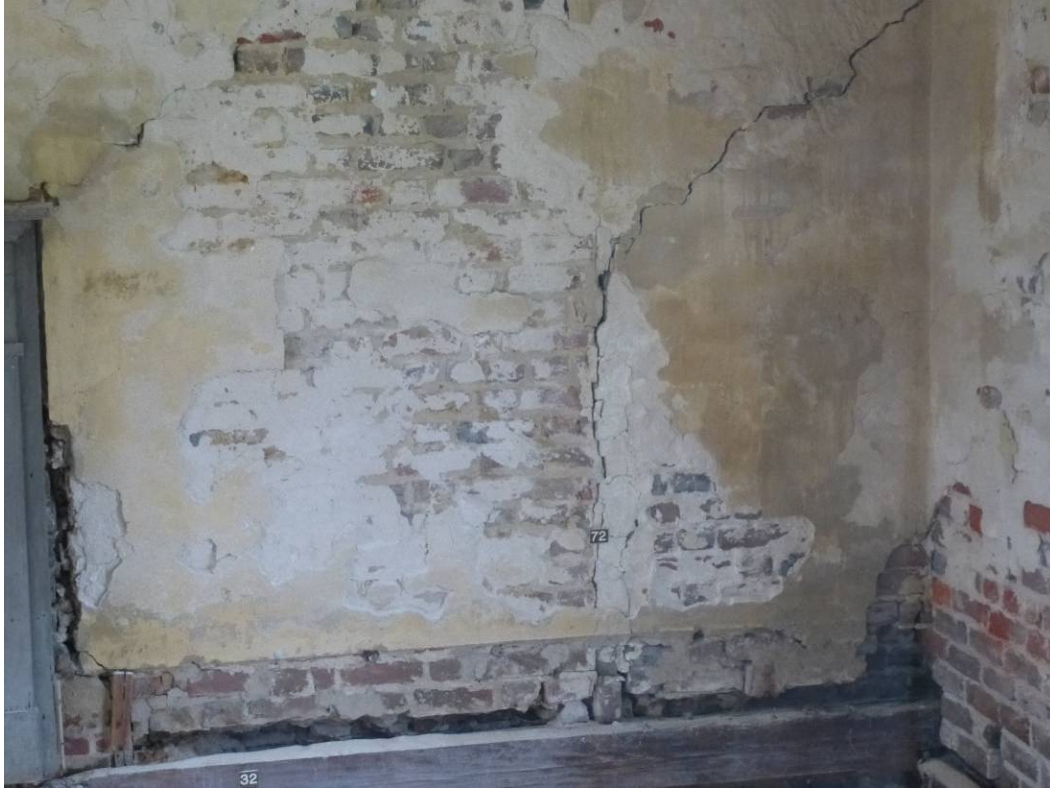
Figure 194. Vertical cracks in the plaster flanking the fireplace are Period I features caused by knee wall studs, left in place during both the ca. 1730 and 1893 renovations. They were plastered over in 1893 and are represented here by cracks in the plaster (ERDC-CERL, 2012).

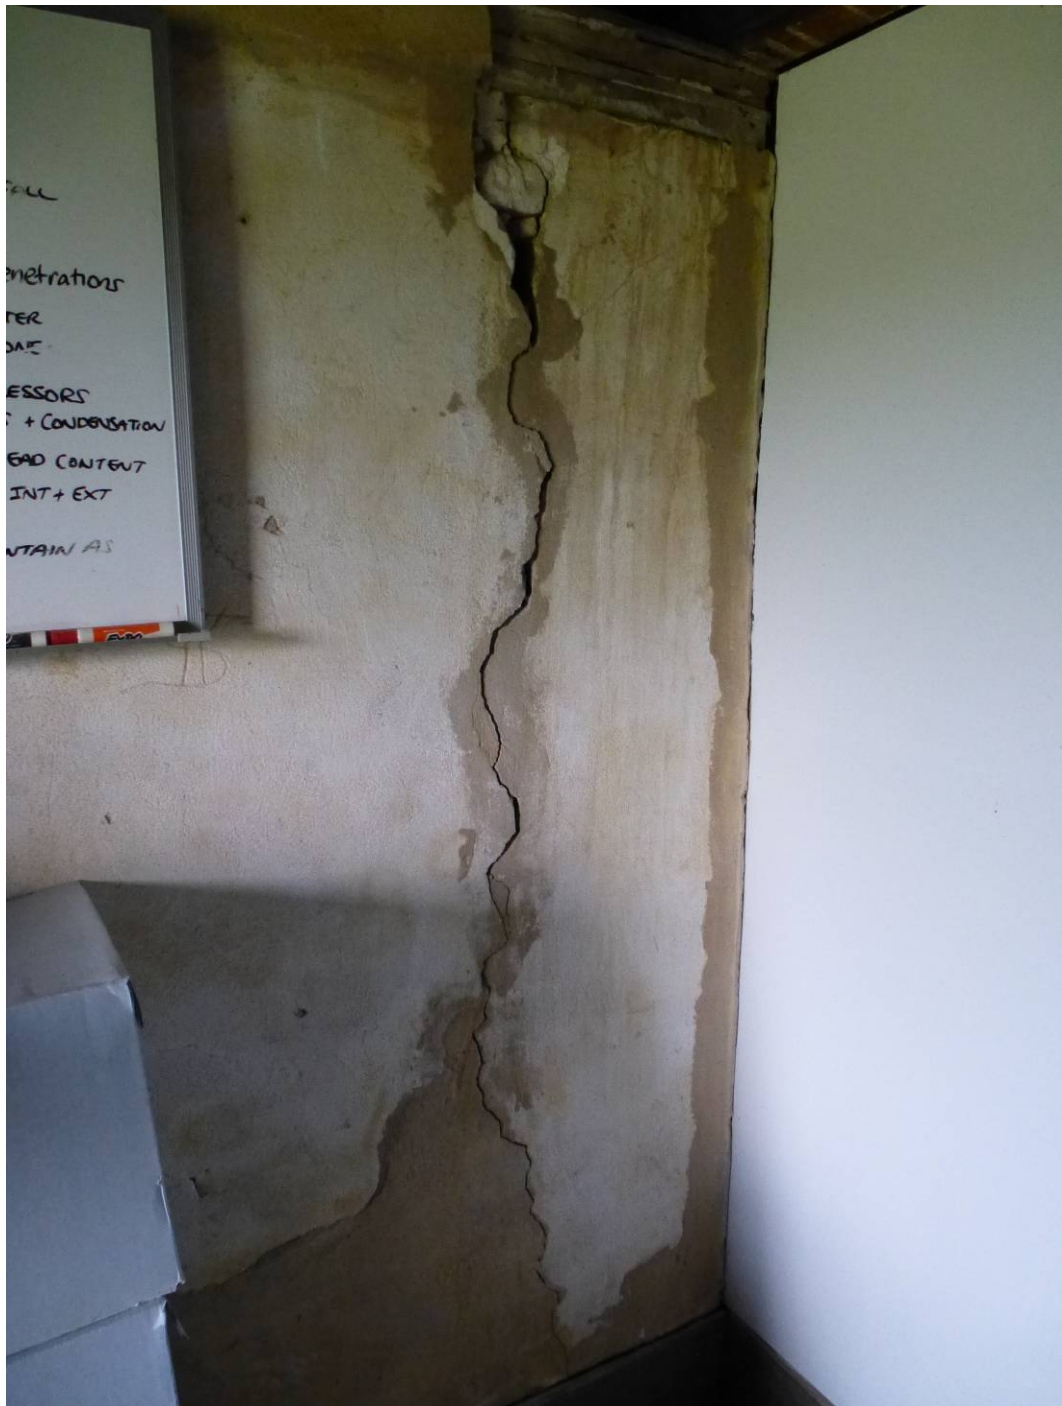
Figure 195. Long vertical crack in plaster. Located in the upper chamber room on the southeast (now office) over the dining room (ERDC-CERL, 2012).

Same as the interior brick concerns described above, the plaster issues need to be addressed immediately (Figure 188–Figure 195). The CRM staff needs to immediately hire a professional knowledgeable in architectural plaster conservation.

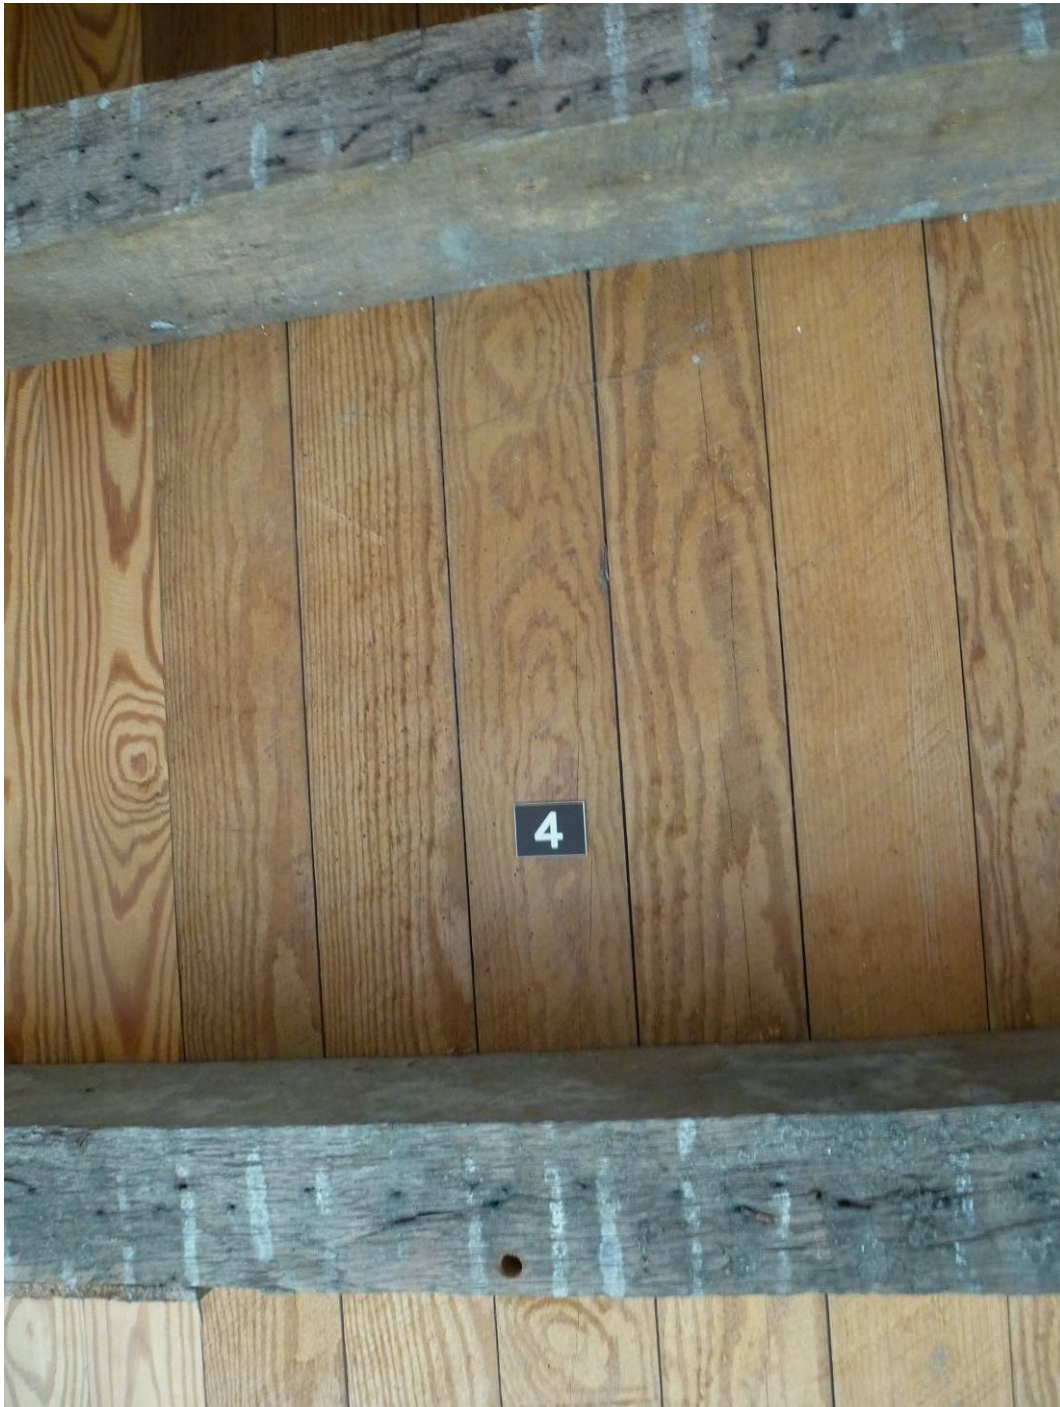
Figure 196. Floorboards (in ceiling above) in the tower (ERDC-CERL, 2012).

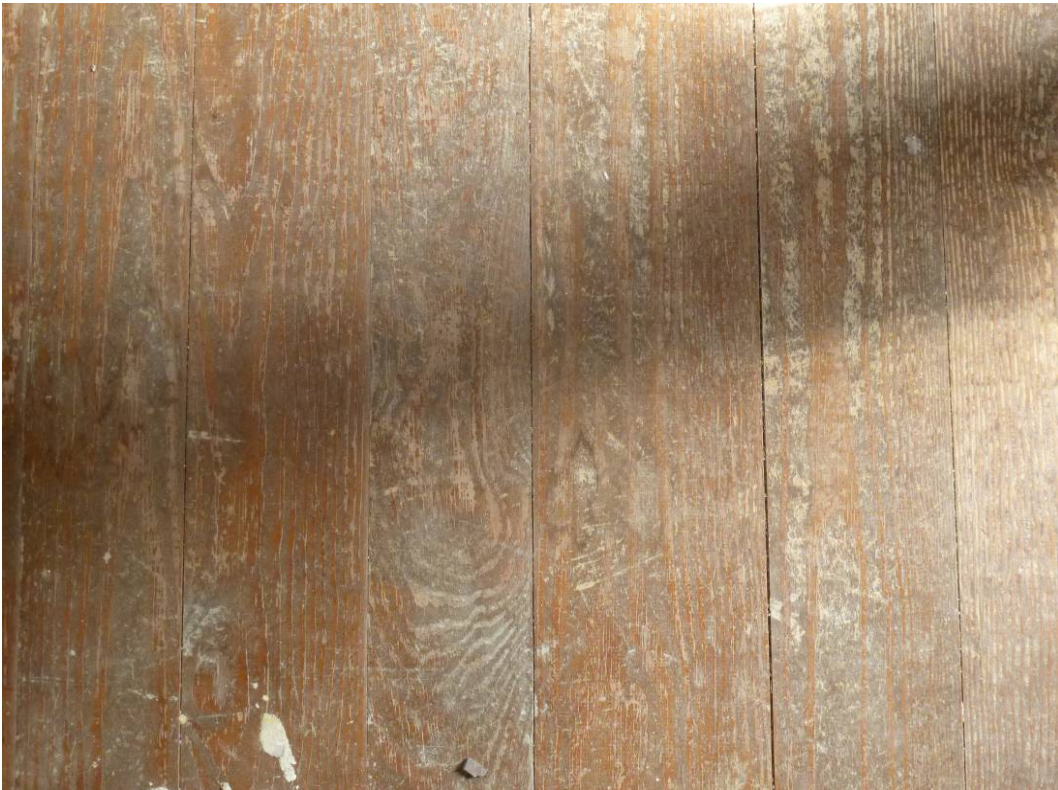
The floorboards shown in Figure 197 were installed in the late nineteenth century, replacing wider heart-pine boards installed ca. 1730. Note the circular saw marks on the bottom face, indicative of timber preparation after the middle of the nineteenth century. Some of the floorboards were replaced during the 1993 preservation efforts.

Figure 197. Typical wood floorboards located throughout the Matthew Jones House (ERDC-CERL, 2012).

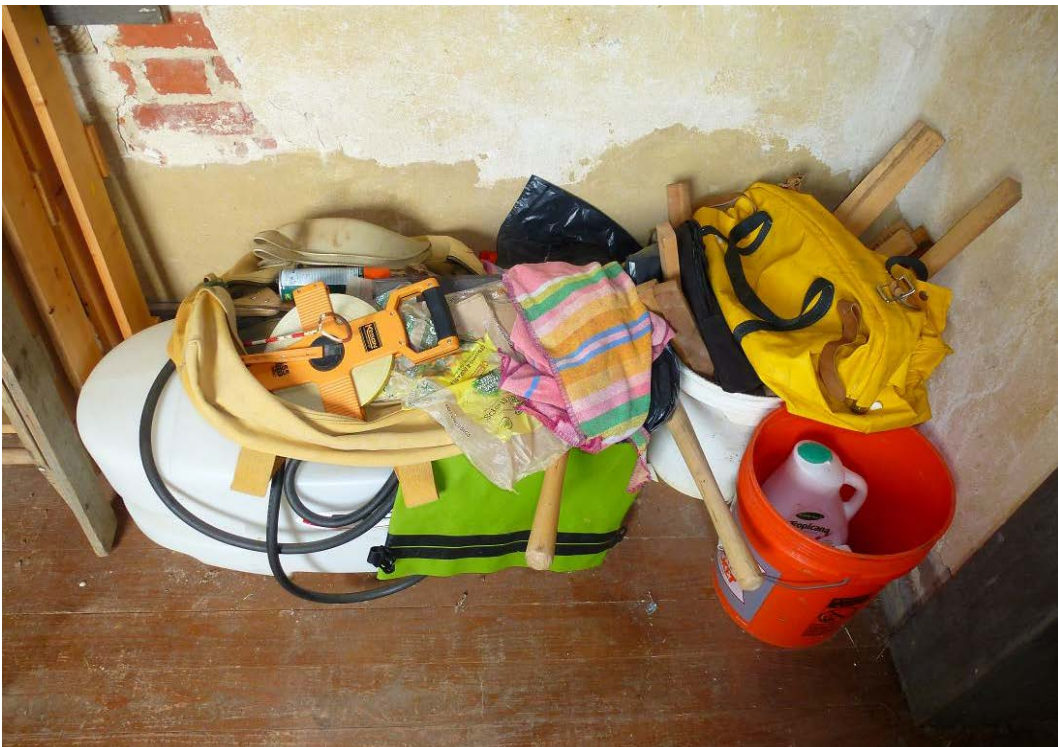
Figure 198. Equipment should be moved off the wood floor throughout the house (ERDC-CERL, 2012).

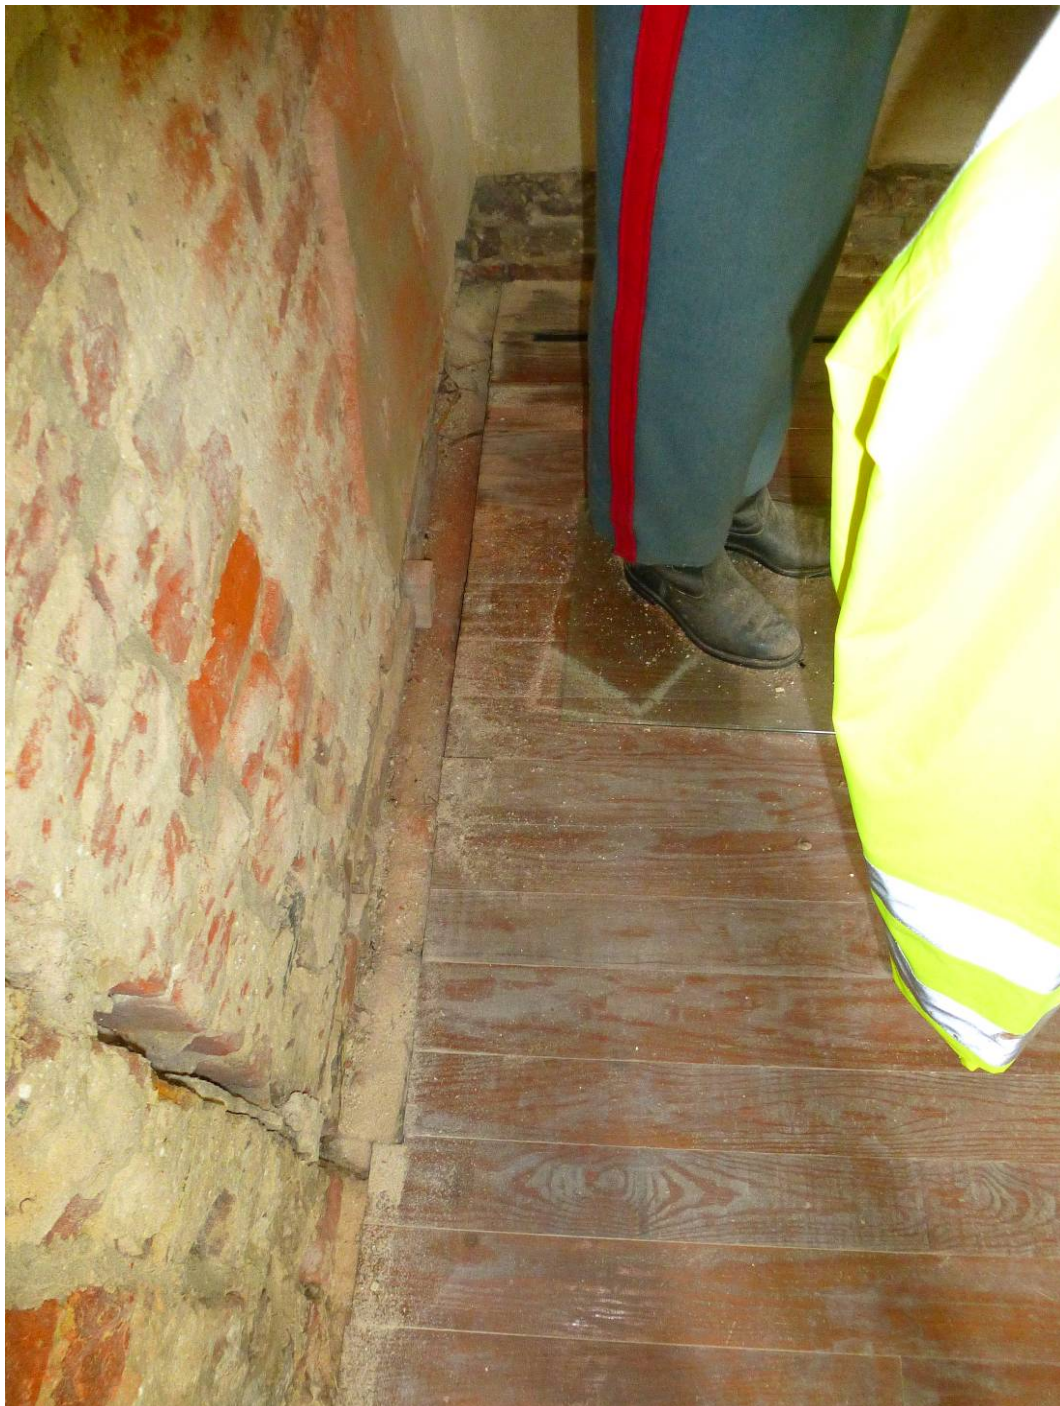
Figure 199. Gap between floor boards and brick wall where the baseboard and the shoe molding have been removed (ERDC-CERL, 2012).

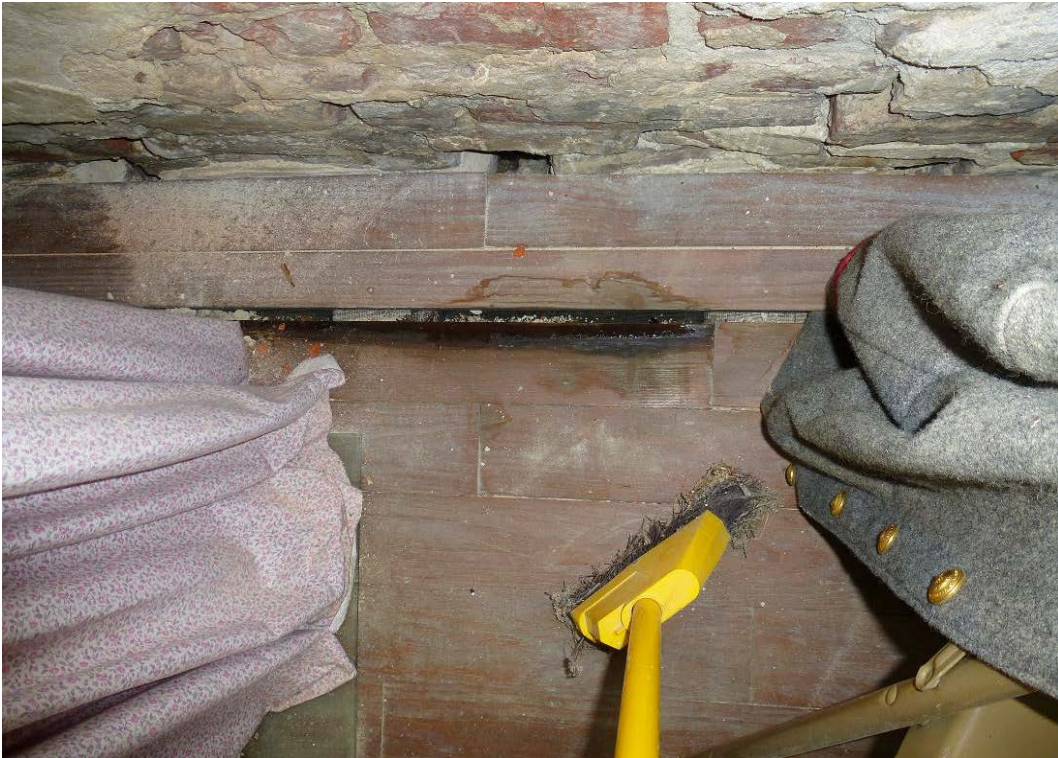
The only immediate concern is part of the flooring in the Matthew Jones House. During the 1993 preservation efforts, a new HVAC system was installed. In order to conceal the floor vents in both the hall and dining rooms, narrow slits were cut into the floorboards. It is a great design and an unobtrusive way of hiding modern HVAC equipment. However, currently the HVAC system is not calibrated correctly for either space, and condensation and moisture are allowed to come in contact with the floorboards adjacent to these vent slits (Figure 200).

Figure 200. A newer HVAC vent has been cut in narrow slits in various places in the wood floor. The moisture from the HVAC system is damaging the floorboards (ERDC-CERL, 2012).

- the slit vents in the floorboards is to be investigated since there is moisture on the wood flooring near the vent openings, and
- cleaning and repair of the millwork and flooring will result only from professional recommendation, and
- any repair or maintenance of the millwork and flooring is to be executed by a qualified professional.

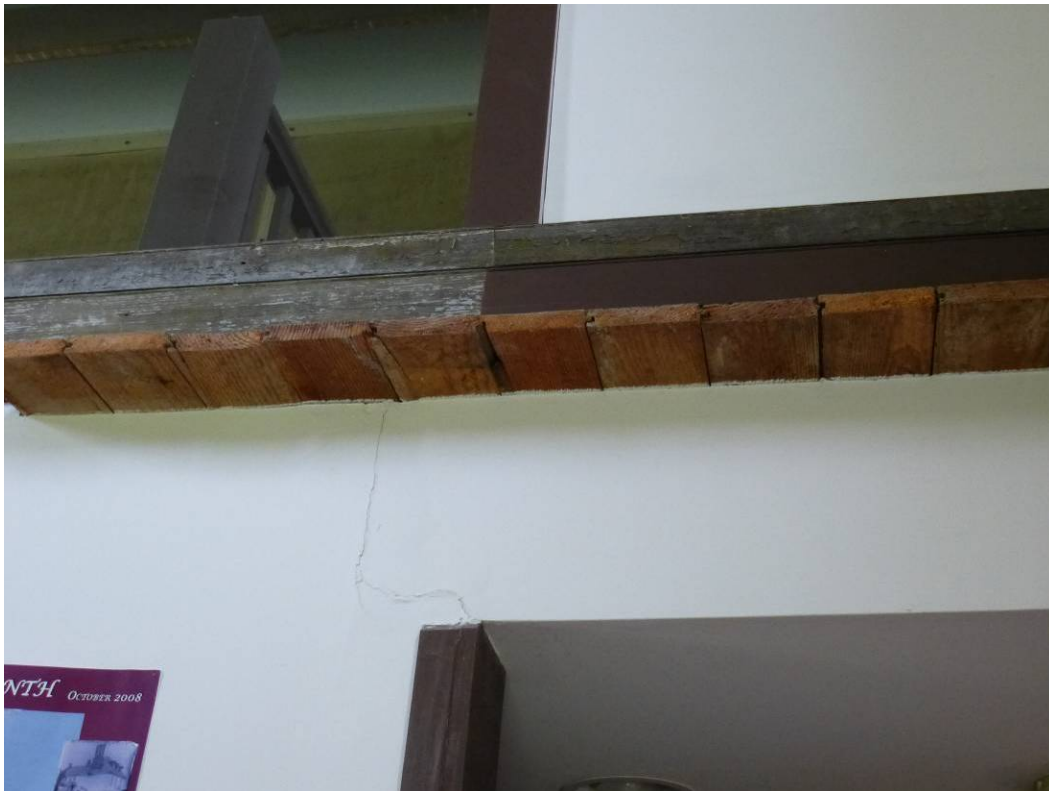
Figure 201. Second-floor tongue and groove floorboards (ERDC-CERL, 2012).

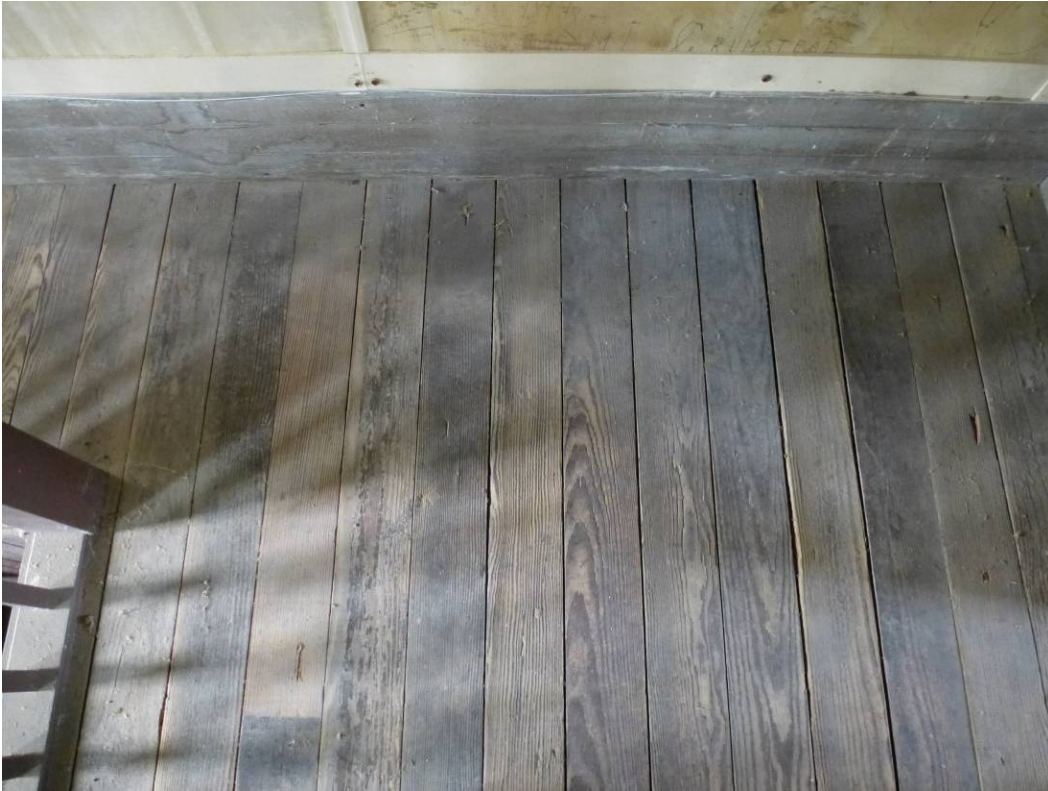
Figure 202. Second-floor wood floor (ERDC-CERL, 2012).

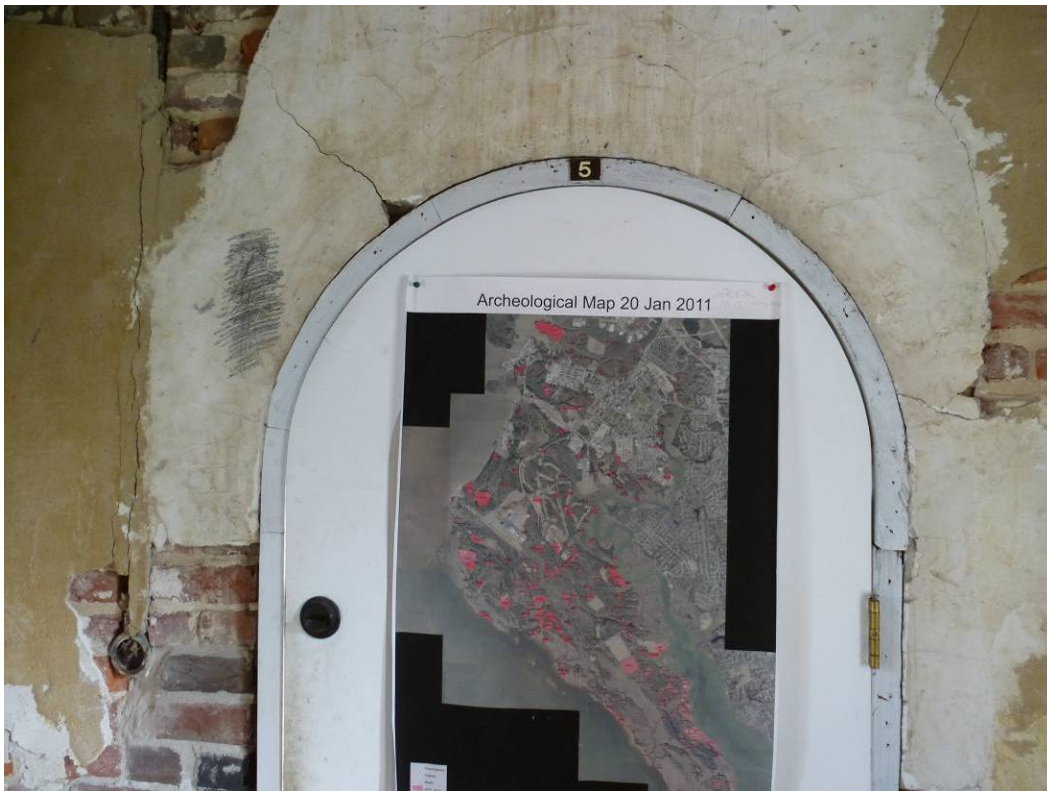
The majority of the original millwork including window and door jambs and baseboard trim in the Matthew Jones House dates to Period III, the 1893 remodeling. The laminated arched door trim around the door leading from the porch to the main block of the house is virtually the only trim from the eighteenth century to survive in the house (Figure 203).

Figure 203. The laminated arched door jamb trim is virtually the only trim from the eighteenth century to survive in the house (ERDC-CERL, 2012).

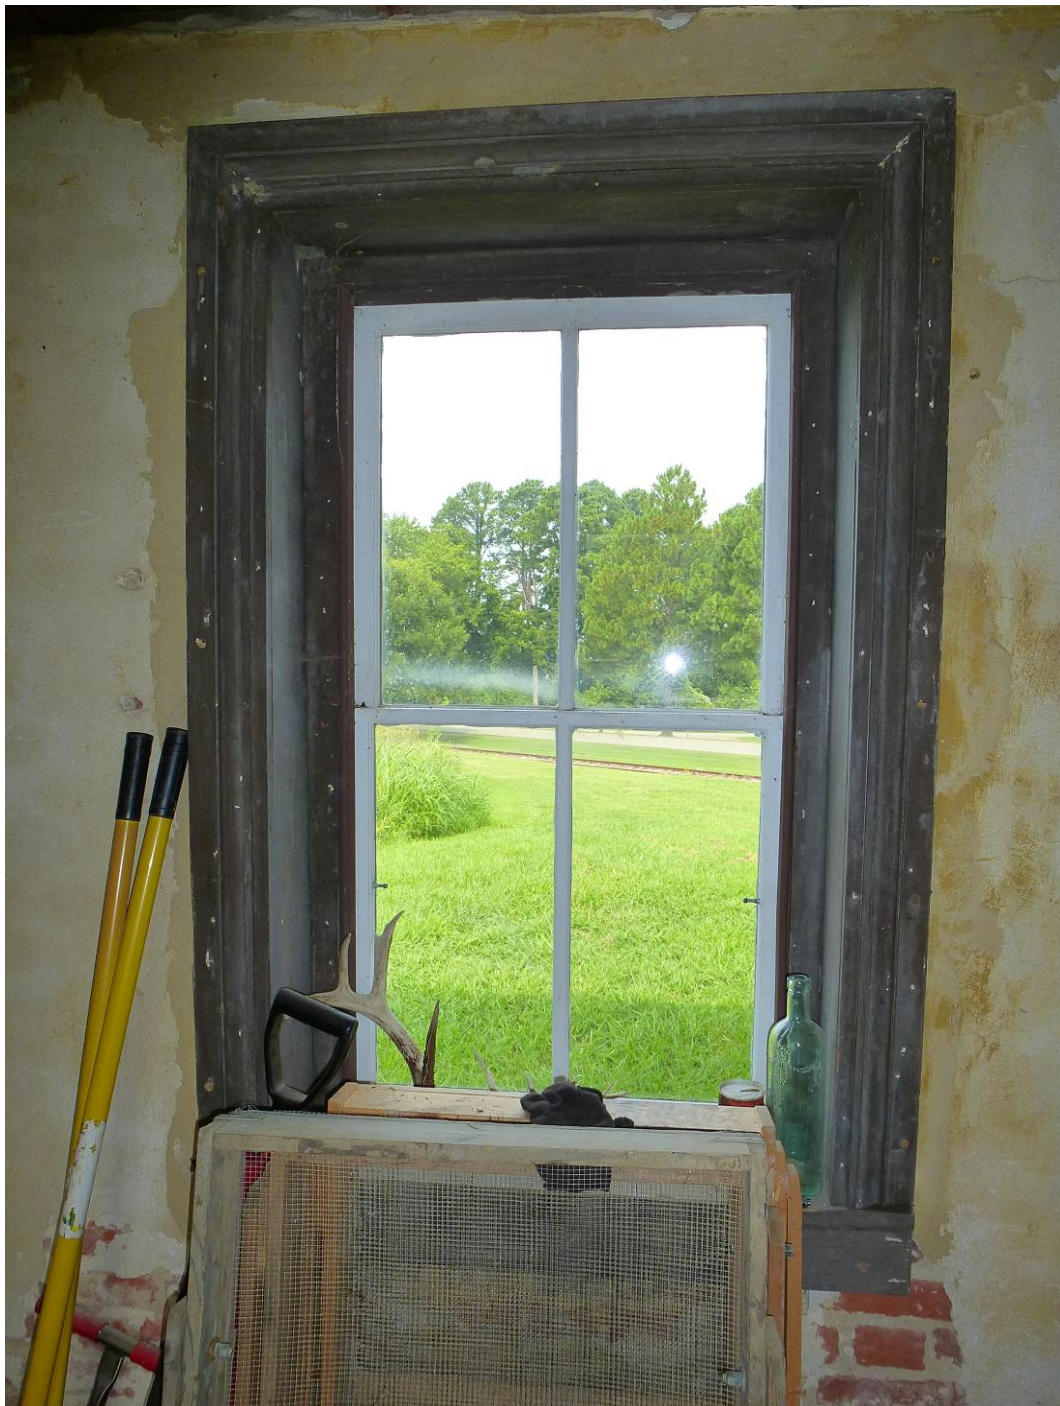
Figure 204. All jambs throughout the house were replaced in the late nineteenth century (ERDC-CERL, 2012).

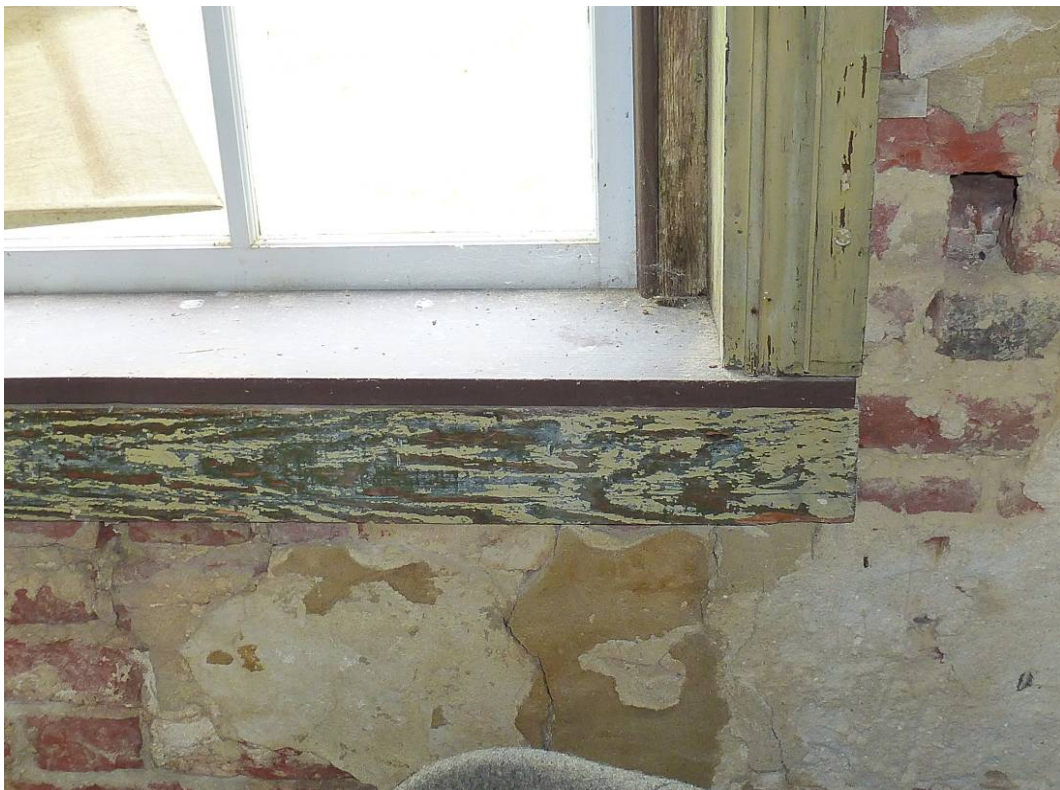
Figure 207. Wood baseboard that is throughout house from Period III (ERDC-CERL, 2012).

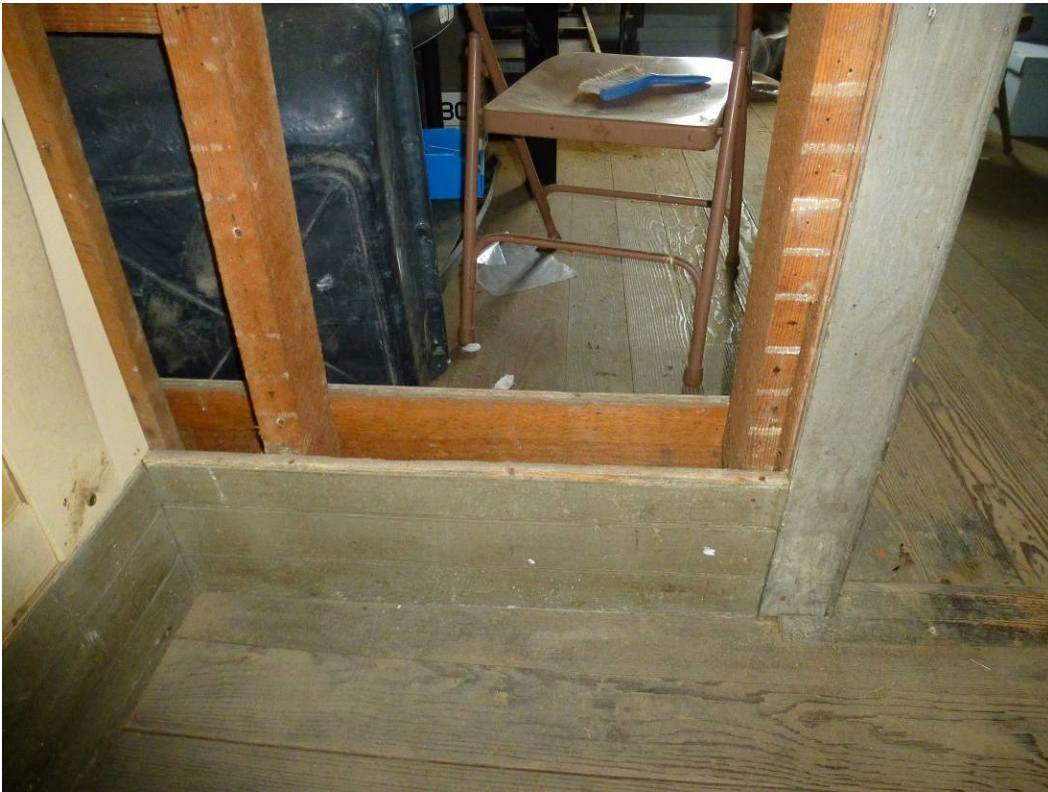
Figure 208. Wood beadboard (ERDC-CERL, 2012).

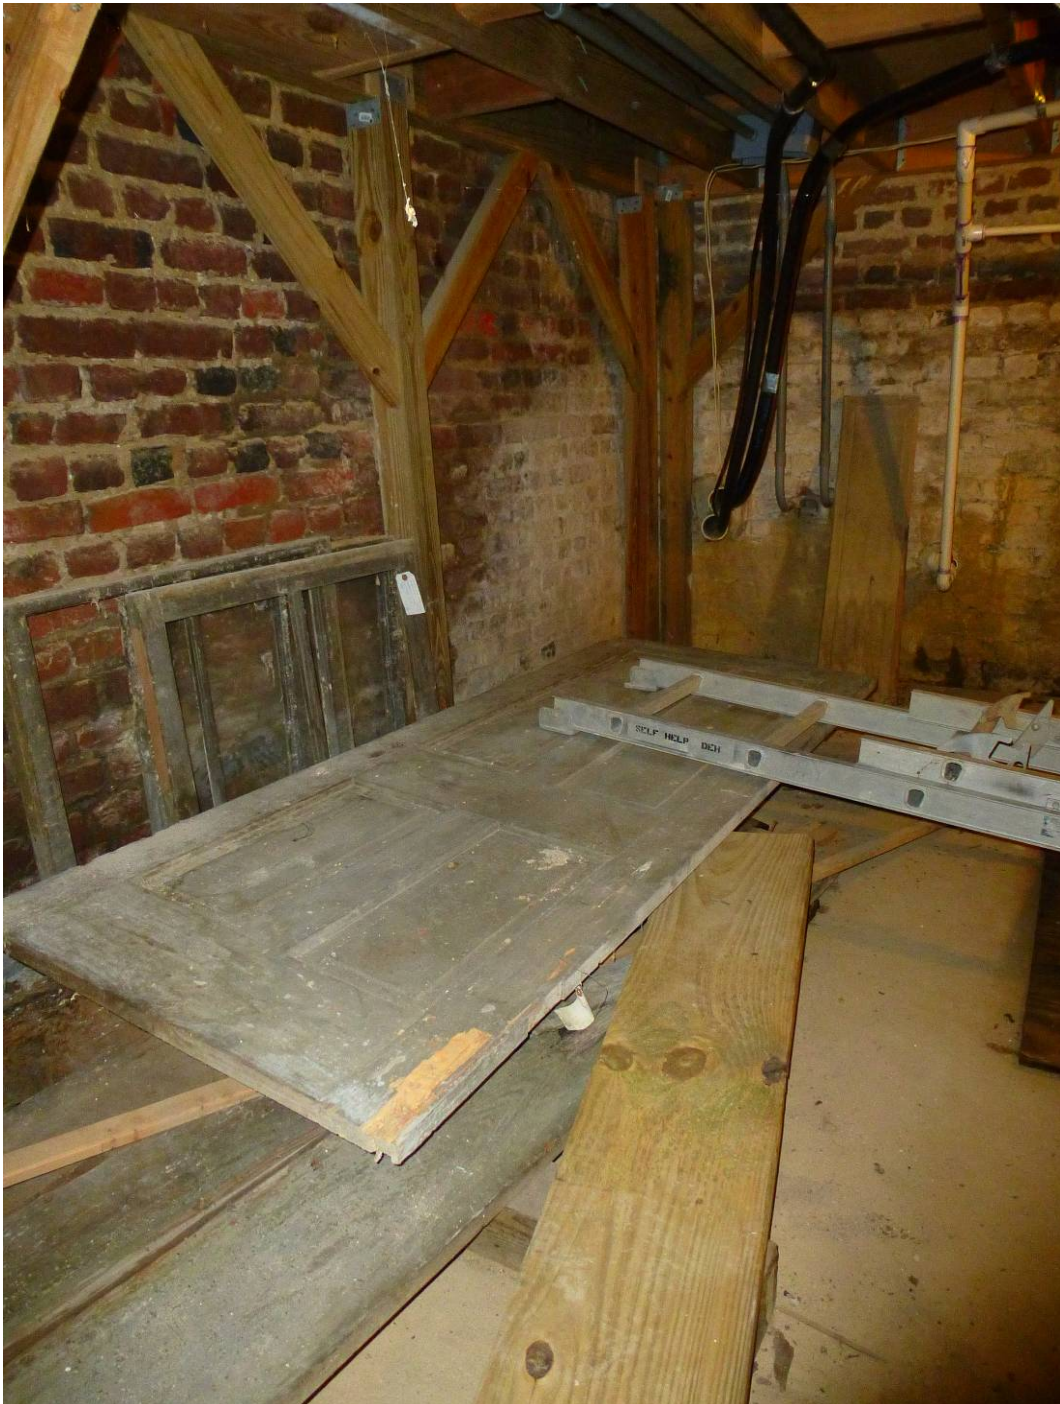
Figure 209. Doors that have been removed and are being stored should be stored in a dry place, unlike this one which is lying on the cellar floor (ERDC-CERL, 2012).

- All of the interior doors are good or better, and
- any wood door that is not attached to a frame and not being used (e.g., the wood door found in the cellar; Figure 209), should be stored in a dry place, and
- the wood frame around each door needs to be addressed, repainted, and
- the wood is scraped, primed, and repainted, and/or
- any broken elements are repaired or replaced as necessary, and
- any repairs to the wood are made after cleaning the surface gently if necessary, and/or

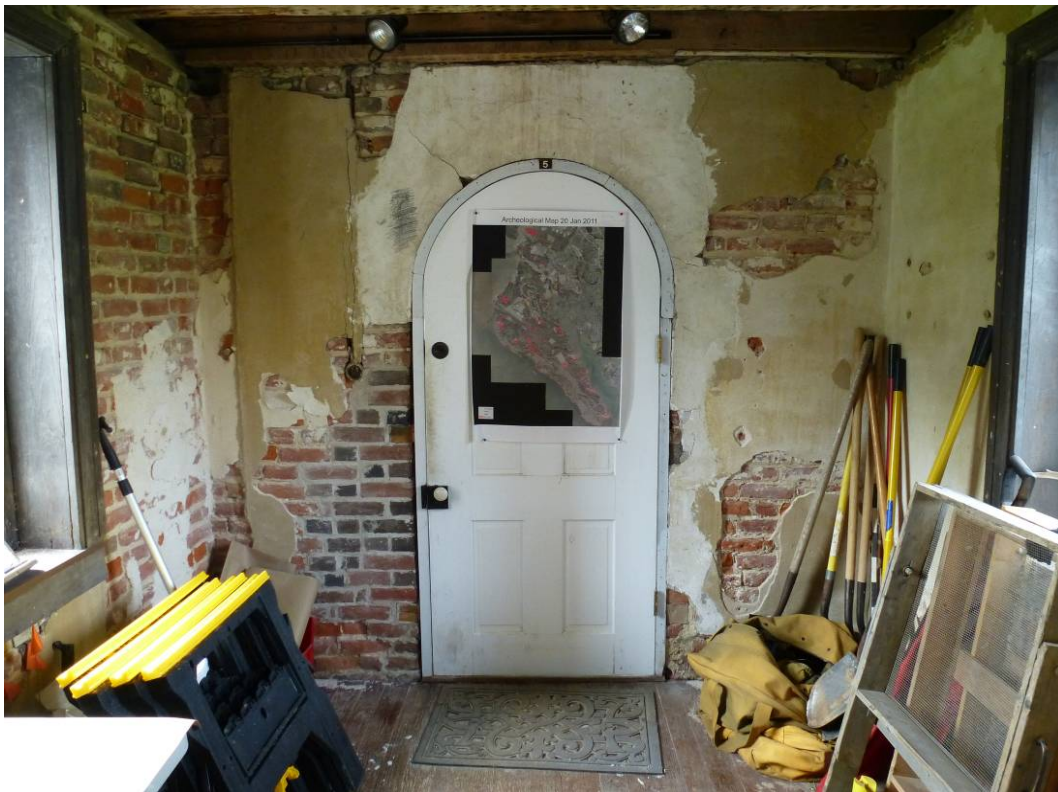
Figure 210. This door leads from the porch tower to the main block of the house. It is a reproduction of that installed in 1893 (ERDC-CERL, 2012).

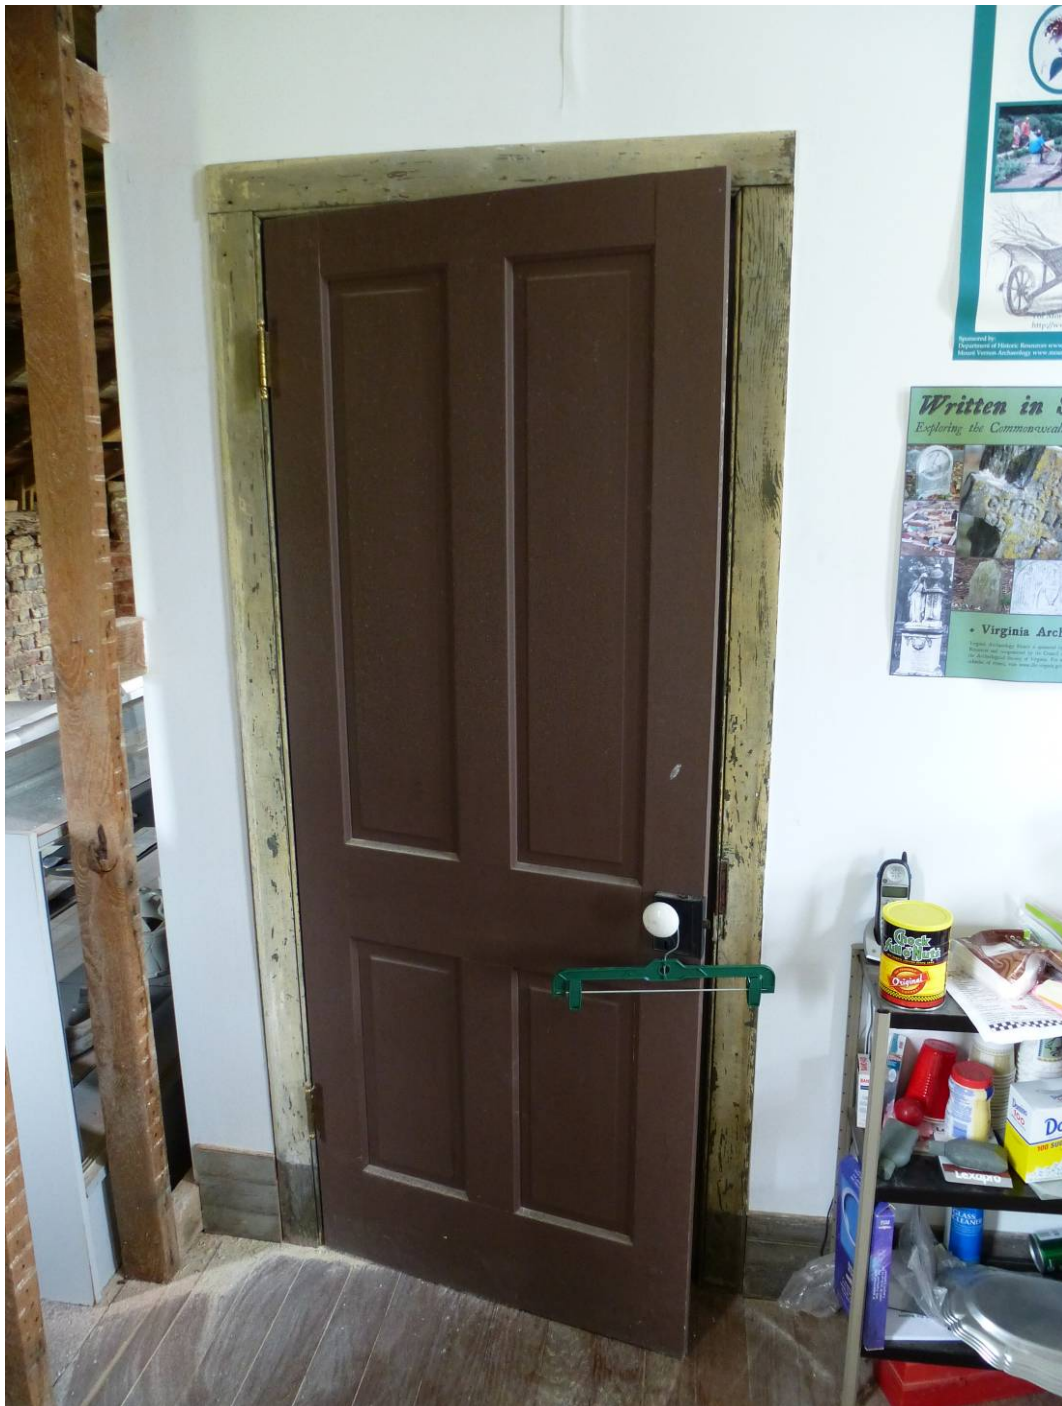
Figure 211. Typical wood panel interior door that has been painted (ERDC-CERL, 2012).

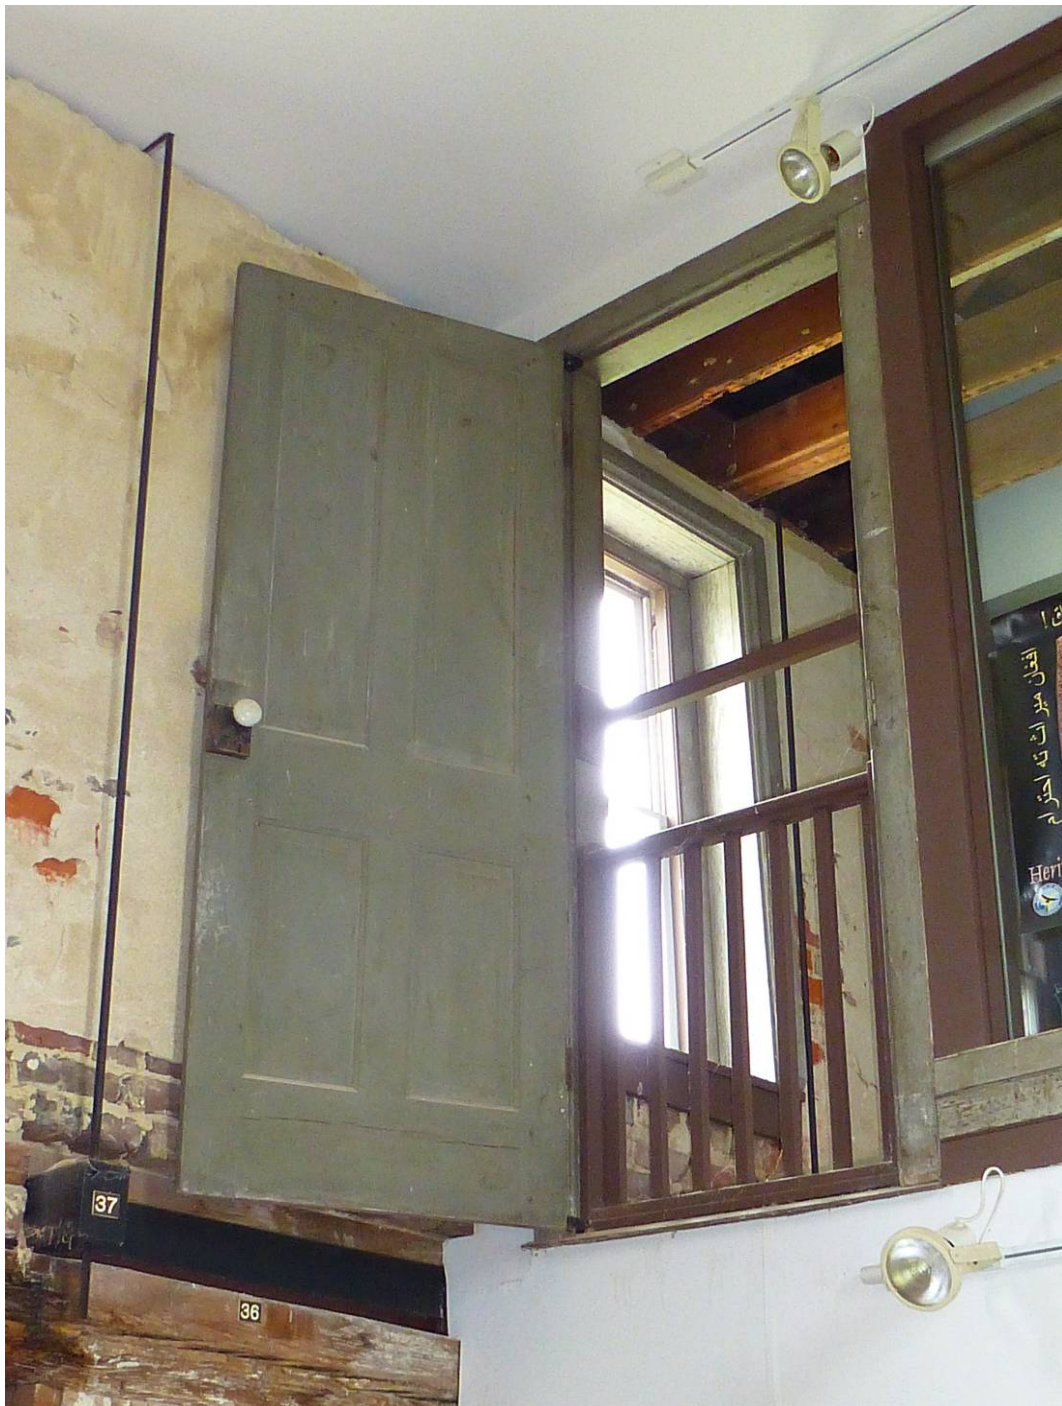
Figure 212. Unpainted wood panel door once leading from upper stair passage to upper chamber over hall (ERDC-CERL, 2012).

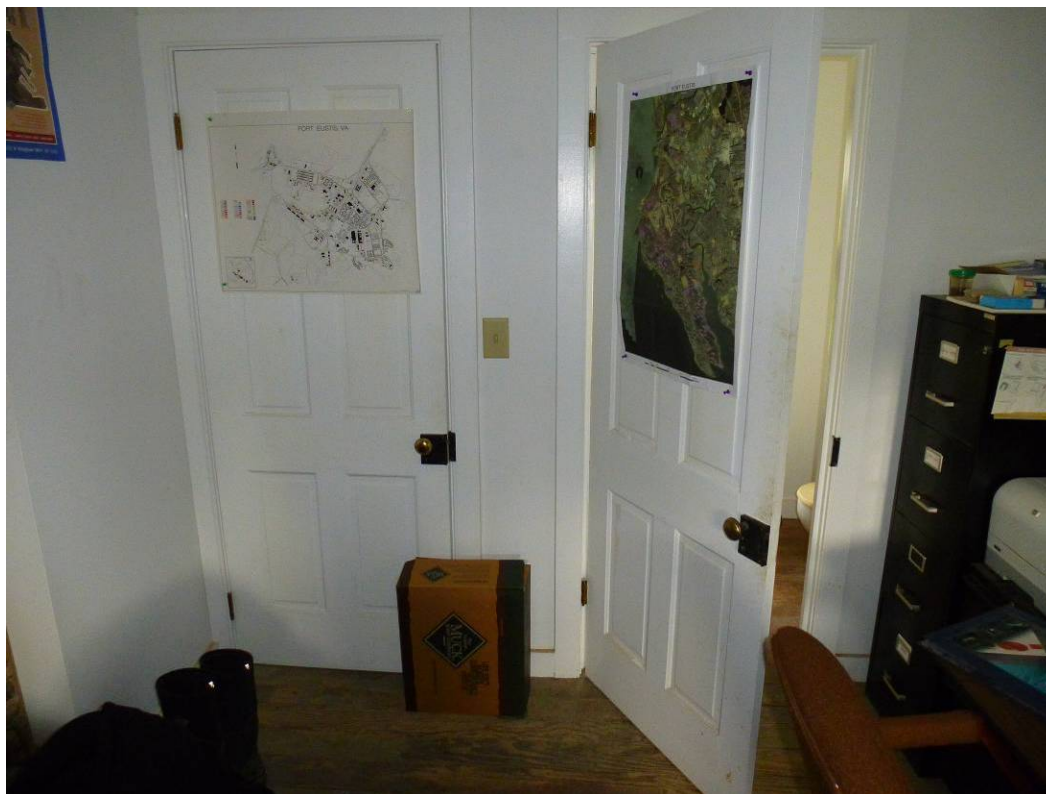
Figure 213. Wood panel doors that were added when the partition wall was built in the upper chamber (now office) over the dining room (ERDC-CERL, 2012).

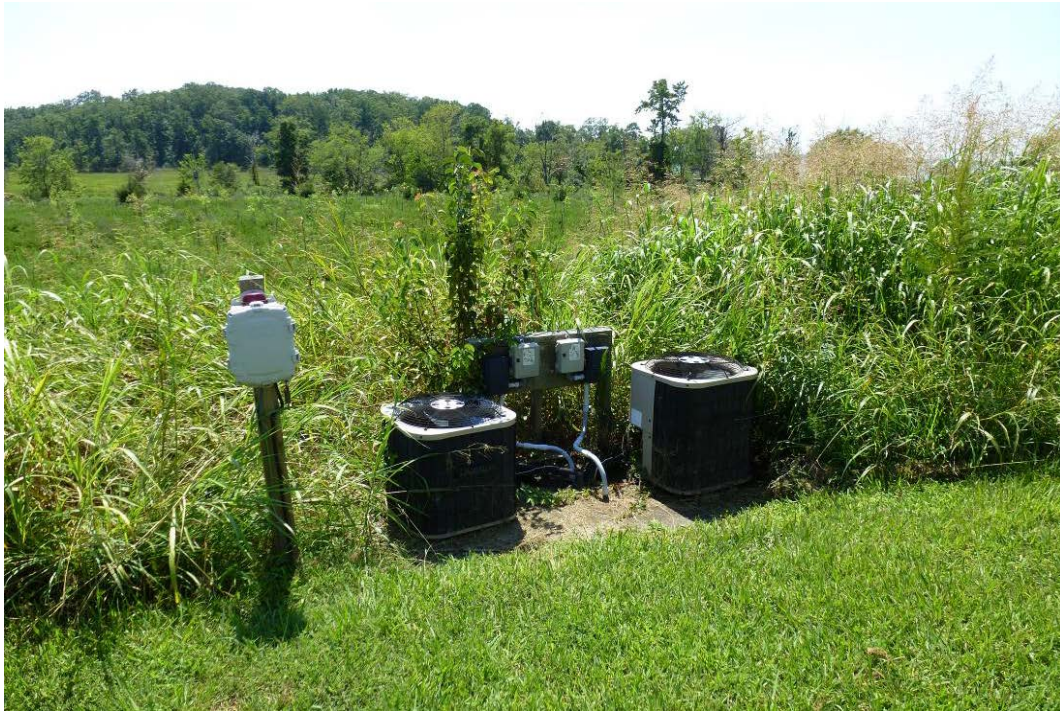
Figure 214. Exterior AC units located on the south side of the property; the vegetation should be cut back and removed where immediately adjacent to the units (ERDC-CERL, 2012).
